Modle : MSX2000 series Tomography Syst

Date : 2010/1/18

The comparison between fluoroscopy image and tomography image

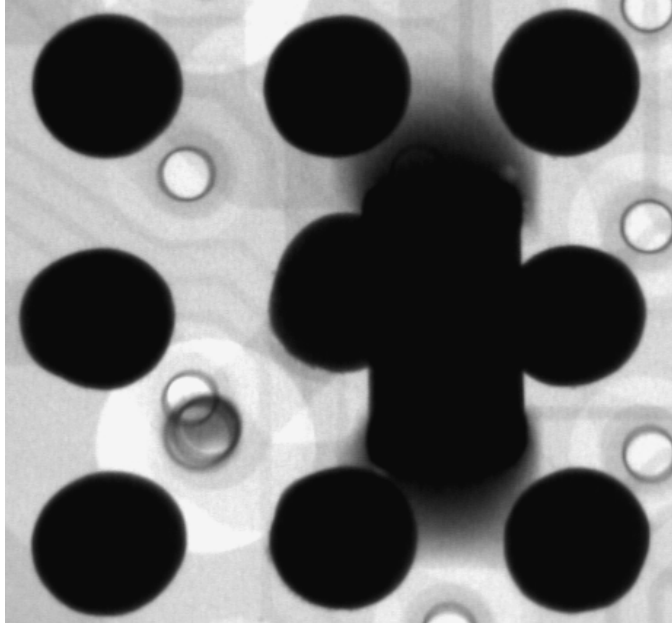
Fluoroscopy image

(2) Ball position error  $\phi$  0. 76 BGA

66kV

35X

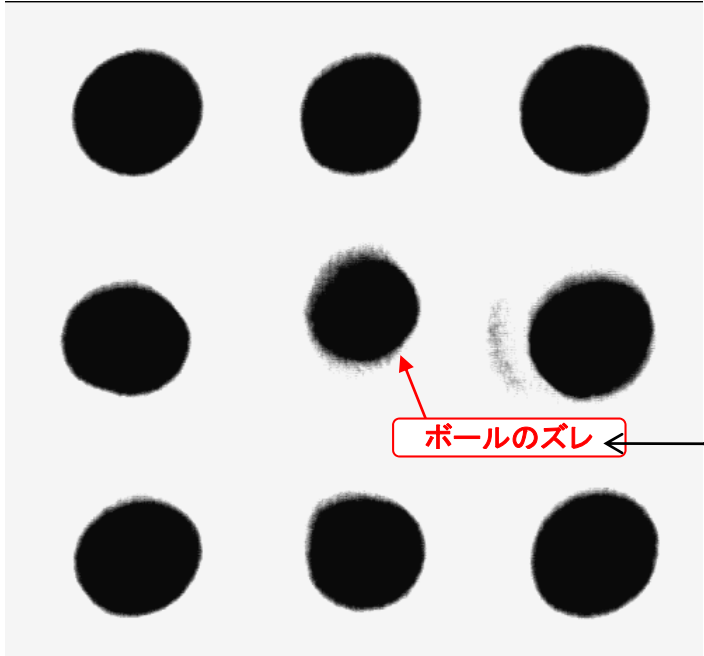
Tomography image

72kV

35X

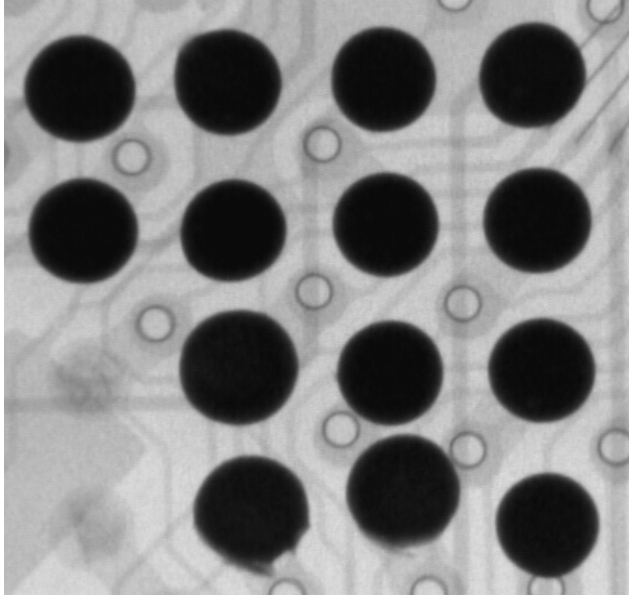
Fluoroscopy Image

(3) Floating ( $\phi 0.54$ )

62kV

35X

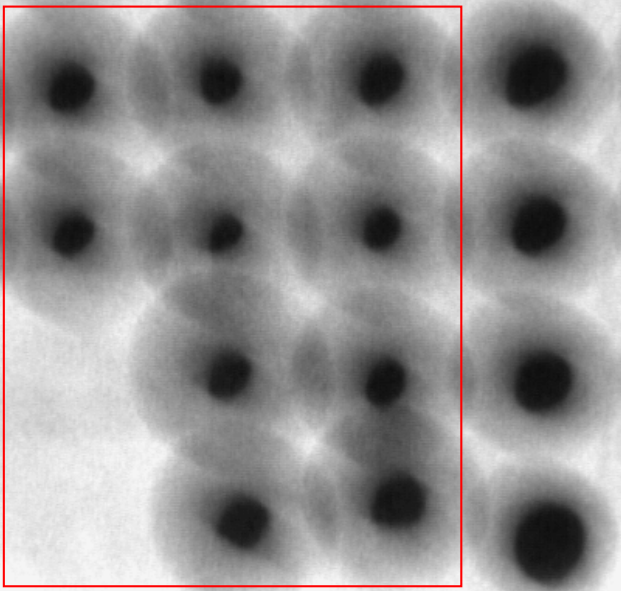
Tomography image

Ball Floating

62kV

35X

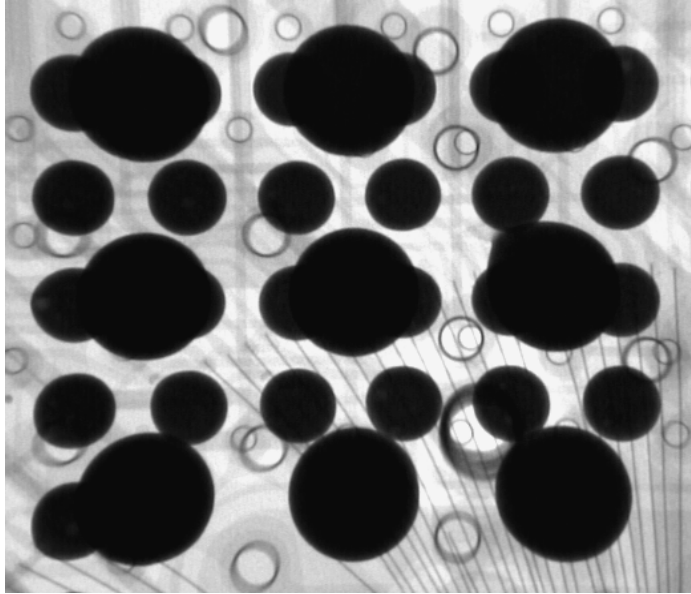
Fluorocopy image

(4) Double side mounted BGA (  $\phi$  0. 76 )

64kV

35X

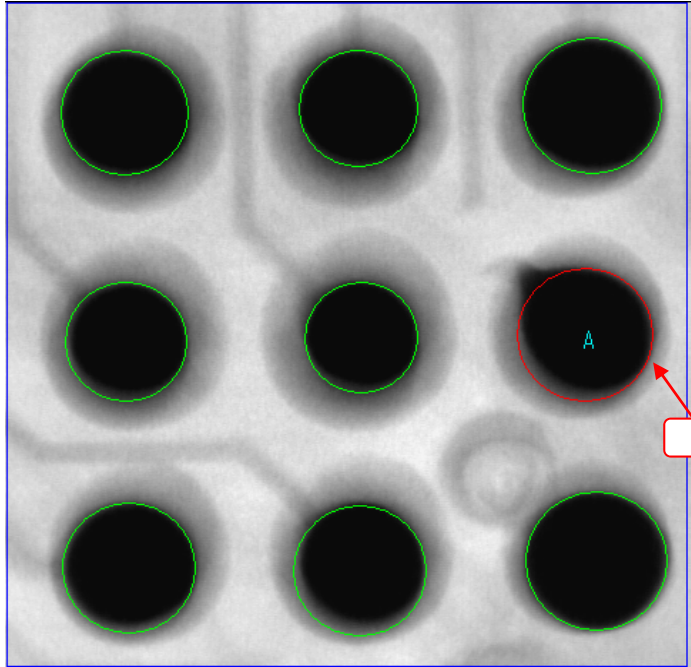
Tomography image

64kV

35X

Abnormal Ball

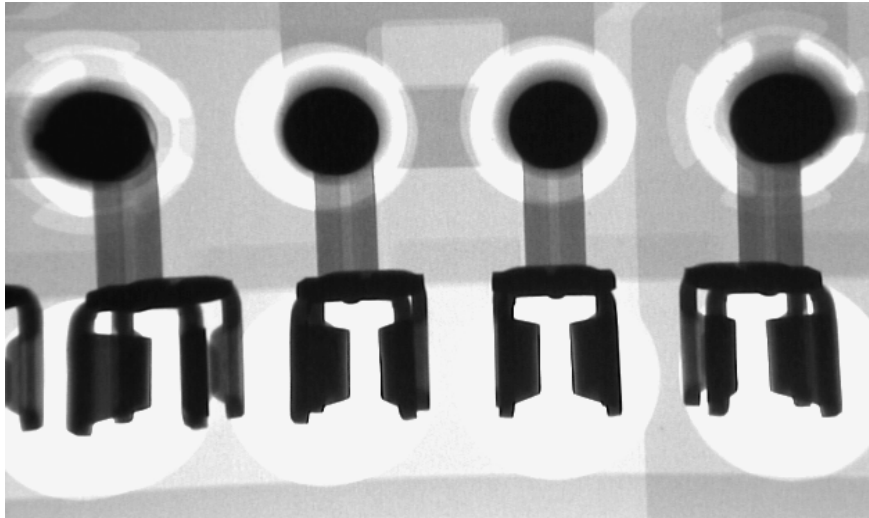
Fluoroscopy image

(5) Lead of the connector

55kV

20X

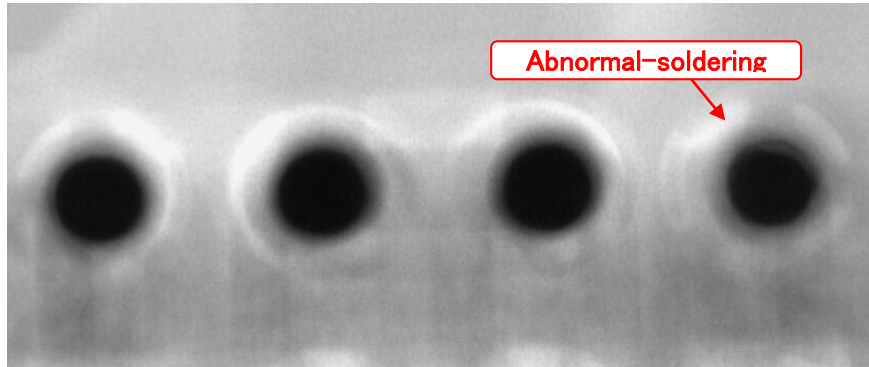
Tomography image

75kV

20X

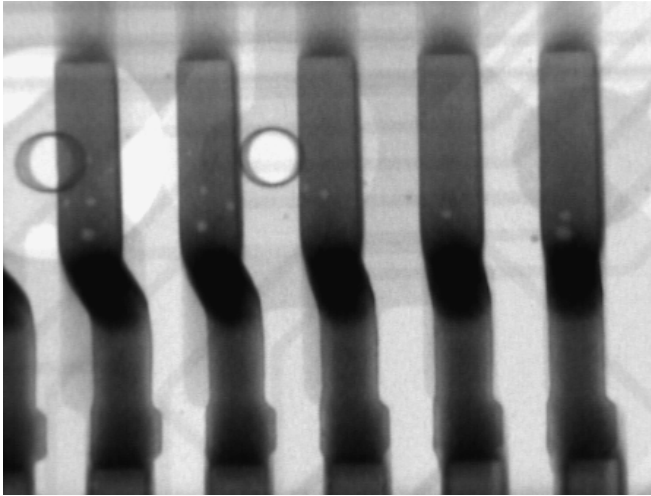
Fluoroscropy image

(6) Back file of the QFP

65kV

35X

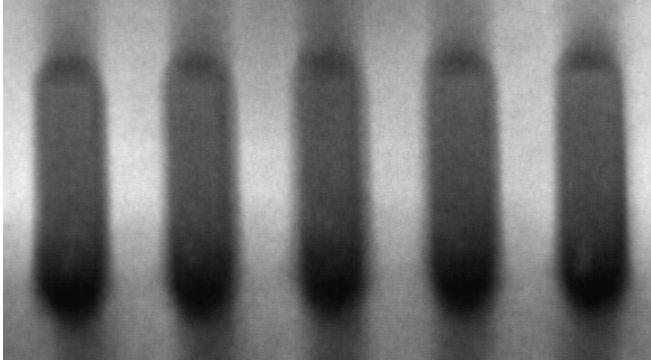
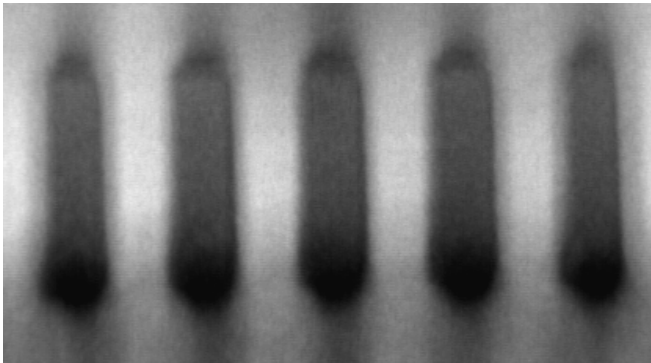
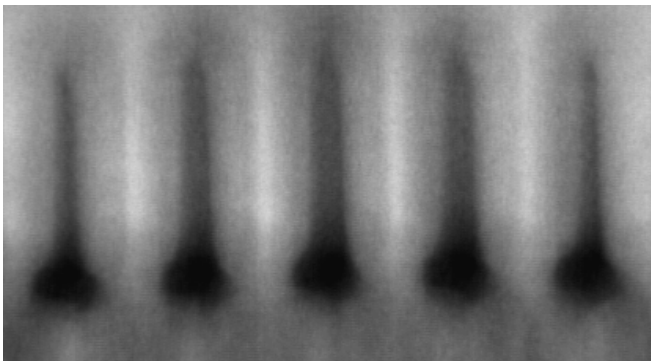
Tomography image

70kV

35X

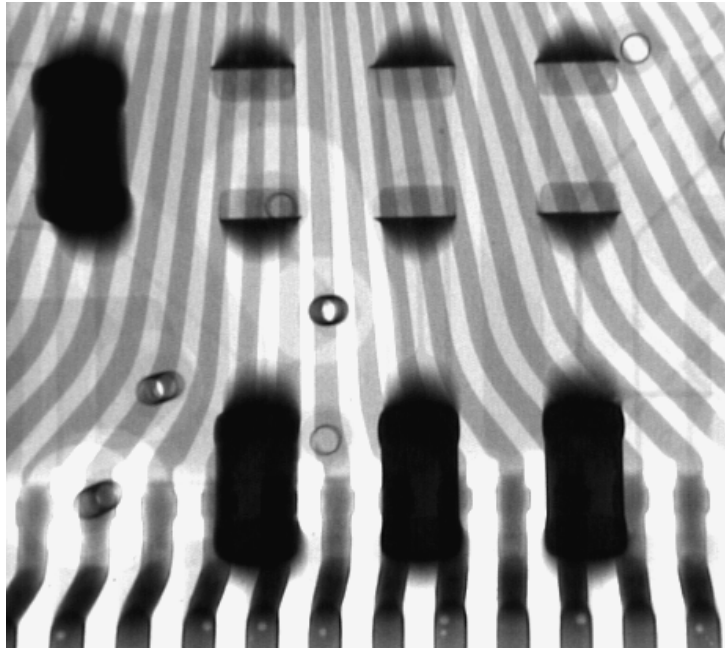
Fluoroscopy image

(7) Resistor & Capacitor

61kV

20X

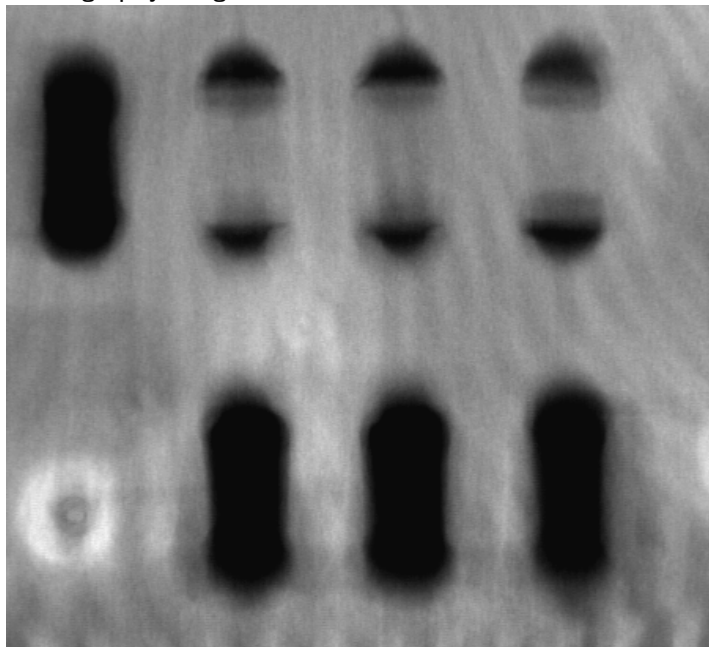
Tomography image

64kV

20X
